92/5  
**M 282**  
**M 332**

### **Rocker arm shaft var. -05**

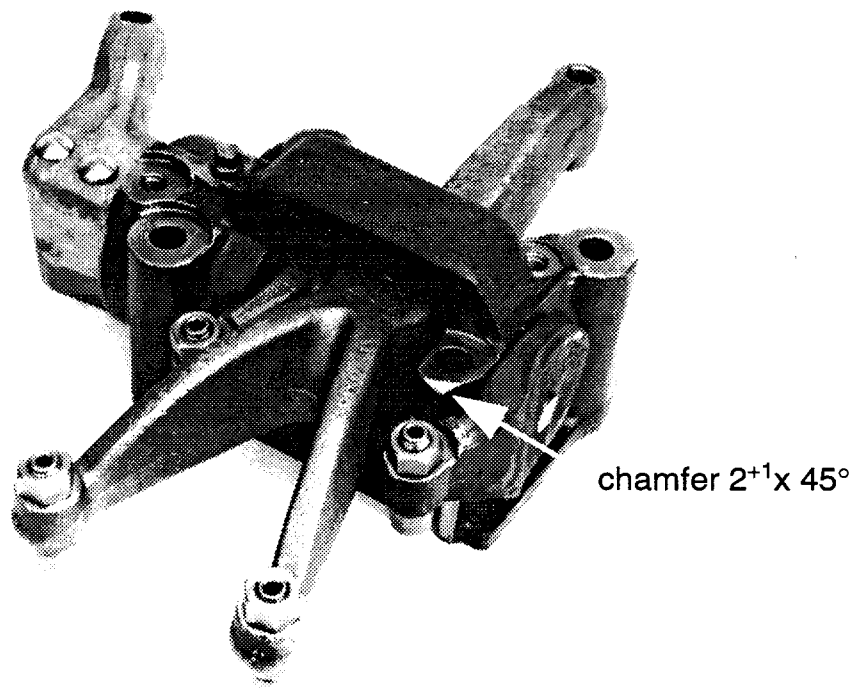
As forged parts cannot be manufactured as precisely as welded parts, greater tolerances must be admitted. The installation of new shafts might, therefore, necessitate a slight modification on older rocker arm brackets.

To ensure a free movement of the shaft a chamfer  $2^{+1} \times 45^\circ$  must be shaped at the left front stud bore on the edge of the rocker arm bracket acc. to the attached drawing.
