Injection pump M32

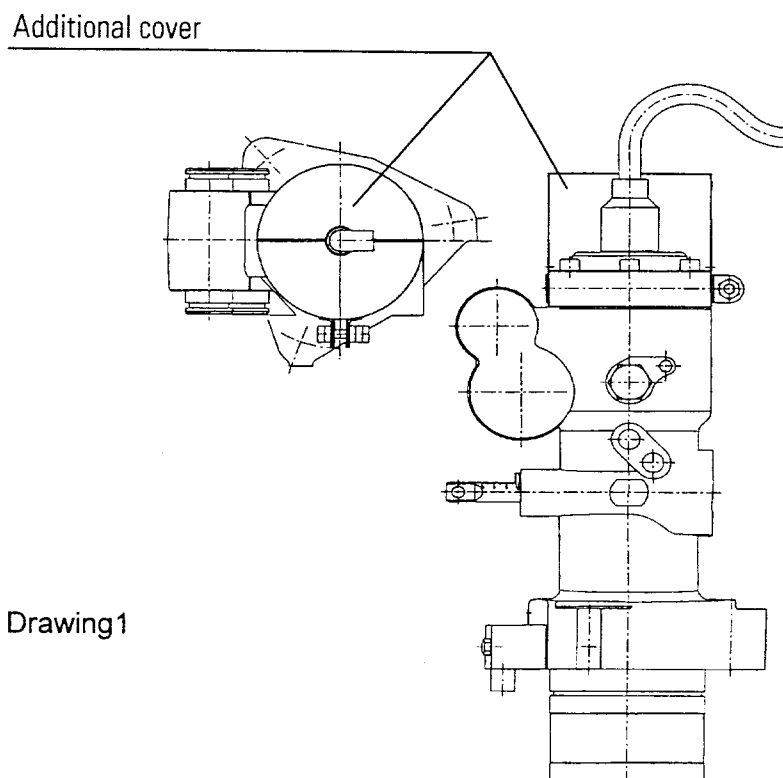
**Drawing1**

In the recent past leakages have sporadically occurred to the injection pumps in the area of the pressure-balancing delivery valve housing / connecting piece, shortly after commissioning within the first 400 engine running hours. They were caused by discontinuities in the material leading to cracks in the connecting piece of the engine. Unfortunately, the small production lot of connecting pieces with discontinuities cannot be undoubtedly assigned to already delivered specific engines.

Normally any danger, either to the engine or to the operating personnel can be excluded because the leaking fuel is protected against its surroundings by the cover of the injection pump chamber. As during trial run and daily maintenance the engine is operated without pump chamber covers, we have provided as further preventive measure a cover for the injection pump connecting pieces, see drawing 1. This additional protection will be fitted by our representative during engine commissioning. The cover protects the connecting piece and in case of damage conducts the leaking fuel safely into the drain channel of the pump chamber. Since all damages occurred during the first 400 running hours, the additional protection can be removed after 1000 running hours. Based on previous operating experiences we expect that the injection pumps will work absolutely reliably after reaching this operating time.
