Service Information No. 00/09

17.10.2000

Cavitation in Sleeve Bearings

M 32

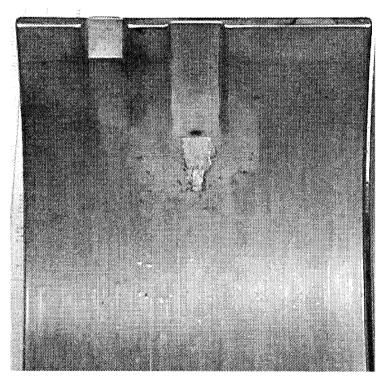
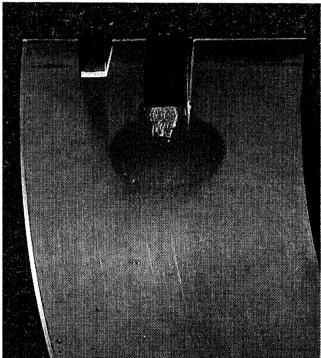
The spots of flow cavitation which partly developed on the M32, only appeared in the run out of the oil groove and consequently they are outside the zone of main load of the bearings. Furthermore in many cases it is observed that cavitation attacks are stopped after the flow conditions have slightly changed due to a certain slight material wear. In all cases we know only the aluminium running layer was affected and not the steel back. That means that the stability of the bearings is not reduced and the worn-off particles of the softer running layer do not endanger other components.

In accordance with the experience in our works and at the manufacturer of the bearings these local cavitation marks do not spell danger for the operating safety. Bearing damages due to cavitation phenomena never occurred on MaK engines and are unknown to us in general.

The pictures show cavitation phenomena which can be considered as examples and are uncritical for the above reasons:

As the described cavitation phenomena were not found on the M32 engines in general, but only on single engines, this is no design fault. Slight differences in geometry from bearing manufacture and fluctuations in the operating conditions of the bearings or a combination of both are considered as reasons.

In order to avoid cavitation in the bearings as far as possible, attention must be paid that the regulations of the engine manufacturer regarding the lub. oil to be used, the necessary care and treatment as well as the admissible pressures and temperatures are observed.
