Guide Bolt Valve Bridge

M43

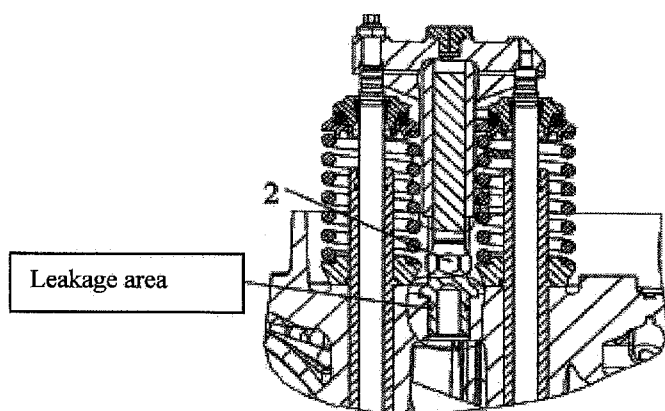
In the recent past we had to ascertain, that sporadically cooling water leakages occurred in the area of the thread to the support of the valve bridge guide bolts in the cylinder head.

Origin of these leakages was a machining defect when manufacturing the threads, by which only a few known production lots of cylinder heads were affected. In the meantime, the machining process has been corrected, so that this defect can be excluded for the future.

To ensure maximum component reliability against such leakages also for all engines, that were delivered before changing the manufacture, we offer to rework all threads for the guide bolts of the valve bridges in the cylinder head.

This rework is a preventive measure for all engines, that were delivered before December 2001. Until completion of rework, engine operation can be continued without restrictions.
