Service Information No. 06 / 03

Cooling Water Pump – New Impeller Fixing

M20

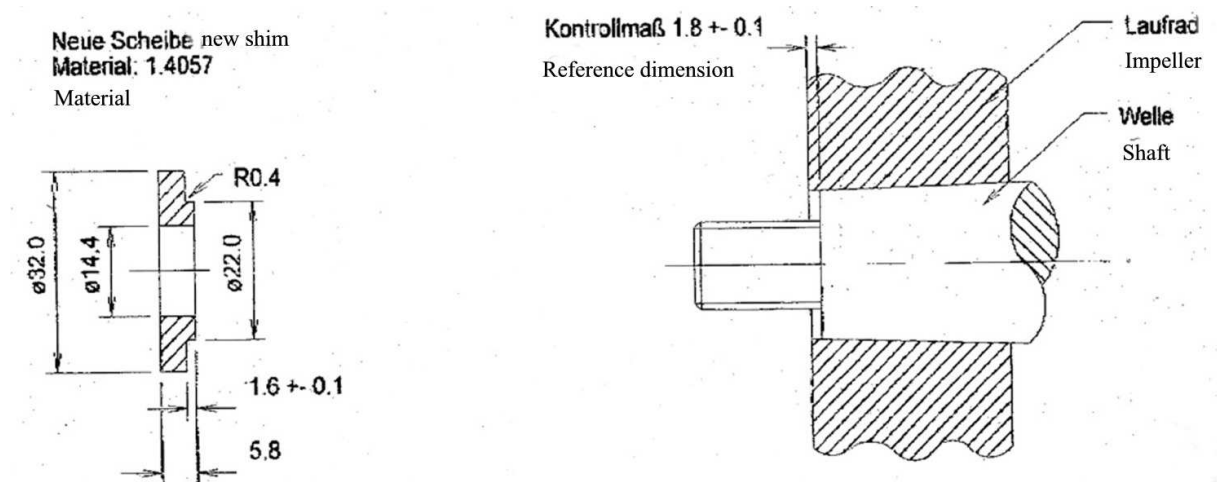
The design of the M20 cooling water pump has been continuously improved in the past. Recently, in isolated cases the state-of-the-art cooling water pumps unfortunately suffered premature failures caused by loose impellers.

- Assembly:
1. Heat impeller up (max. 200°C) and slide it on the shaft (reference dimension 1.8 ± 0.1 mm).
 2. Mount the shim. (Recess shows into the direction of the impeller).
 3. Tighten nut with 90 Nm and lock with the 2nd nut (secure with Loctite).

1. Loosen the nut.
 2. Remove the shim.
 3. Heat impeller up (max. 200°C) and loosen from the shaft using the extractor.
- Attention: Impeller and extractor might jump off.
