Service Information No. 03 / 04

Date: 02.06.2004

Screwed Connection between Piston Crown and Skirt

M 43

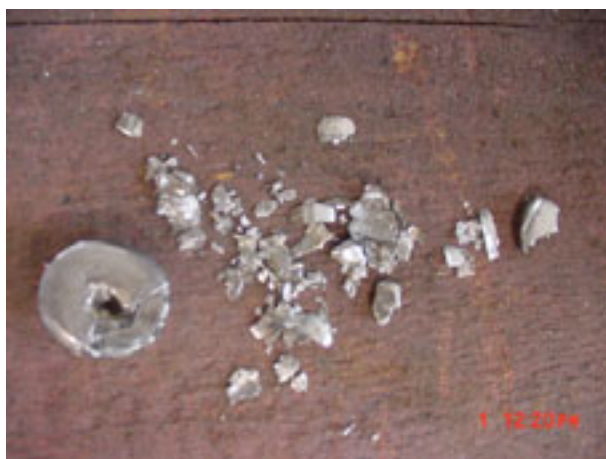
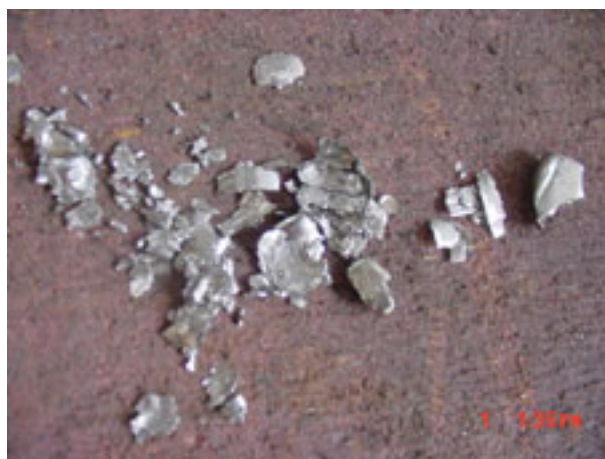
These chips may indicate a problem with the connecting bolts between piston crown and skirt:

In case you find indications as shown above do the following:

- **Do not restart the engine**
- **Contact your nearest Customer Service**
