## Service Information No. 06 / 04

Date: 28.07.2004

### Pressure Switch in the Cooling Circuit

6,7,8,9 M43 900kW/cyl.

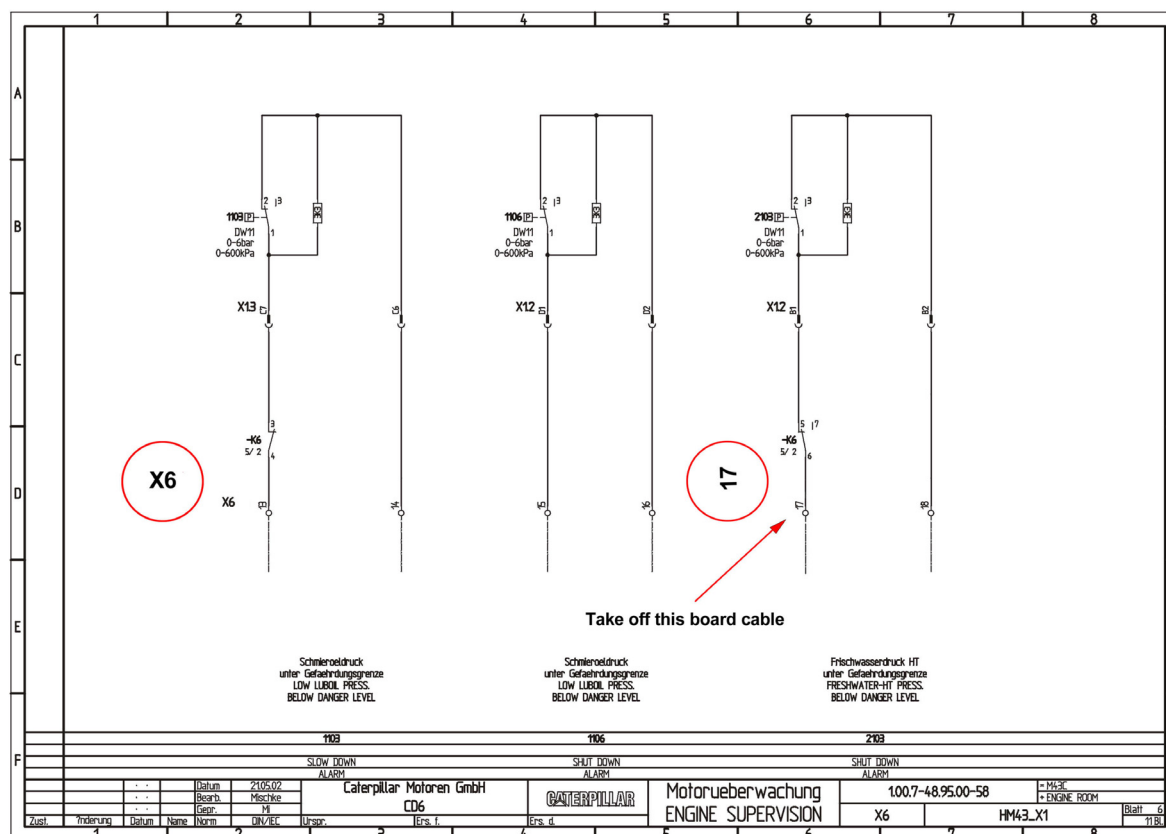
There is evidence that in two instances engine shutdowns occurred on board due to false alarms of the cooling water pressure switches. In both instances the cooling water pressure was normal. It was not possible to reproduce the false alarms. Subsequently, it was identified that in exceptional cases the operating conditions relevant to the switch have caused those false alarms. As the actual condition of each individual pressure switch is not known and therefore in rare cases false alarm cannot totally be excluded, we have decided, with the consent of the relevant classification societies, to disconnect the automatic engine stop due to shortfall of the cooling water pressure below the adjusted shutdown value until final technical clarification of this issue. The cooling water pressure alarm circuit continues to be fully functional, which also includes automatic start of the standby pump.

At terminal strip X6 the board cable must be removed from terminal 17.
