## Service Information No. 09 / 04

### New sealing ring for pushrod guide on the cooling collar **M43**

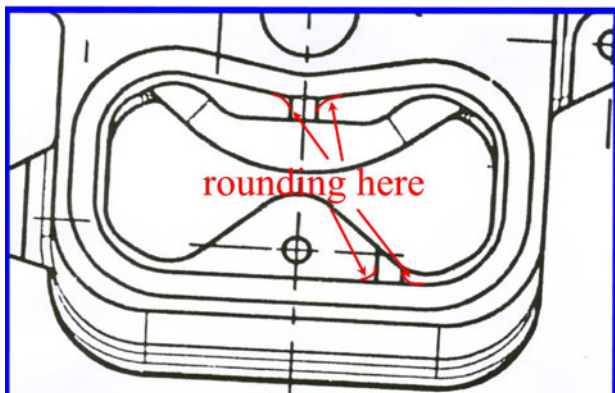
Figure 1

On the pushrod guide of the cooling collar there occurred some isolated instances of oil leaks in the area of the cylinder head connection point. In the course of time the sealing ring lost its sealing capability. A new solution has already been implemented in the current series production (VM43, M43, M43C).

The edges of the oil drain are to be rounded with radius  $r = 4$  mm (see figure 1). This can be carried out by means of a metal removing tool such as a pneumatic cutter, a grinding tool or a file.

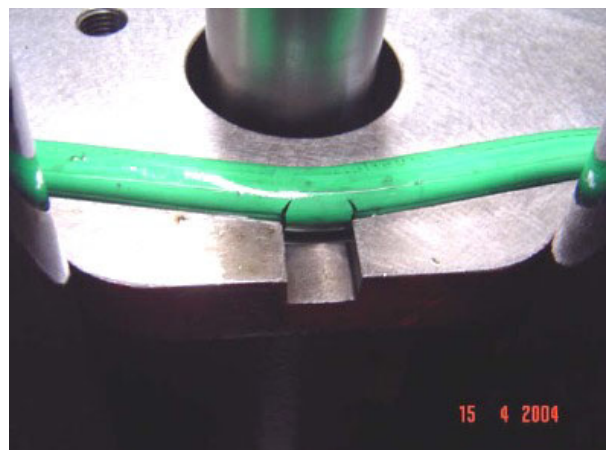
Figure 2

If this required rework is not carried out, there is a risk of the new sealing ring getting damaged by the edges of the oil drain (figure 2).
