Service Information No. 10/05

Governor Drive Evaluation of the Operating Pattern

M 43

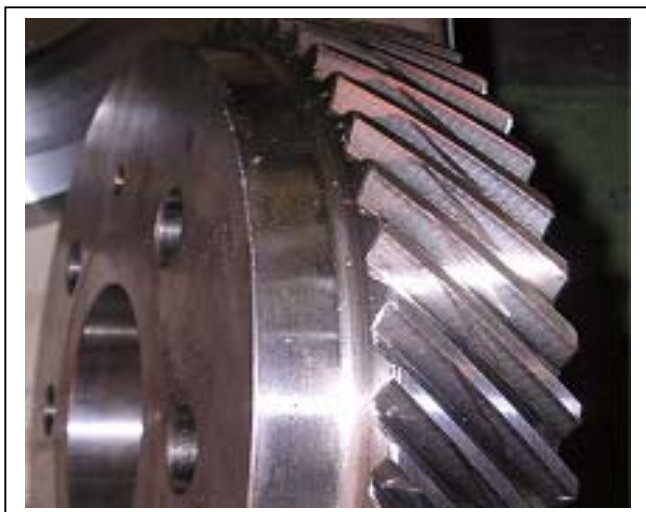
Figure 1
In-line engine M 43
after 1,000 operating hrs.

Photos 1 to 3 show normal, perfect running patterns of governor drives at different running hours. The adaptation can be clearly recognized. Slightly palpable running patterns on the gear flanks are totally harmless and permissible. No replacement is required.

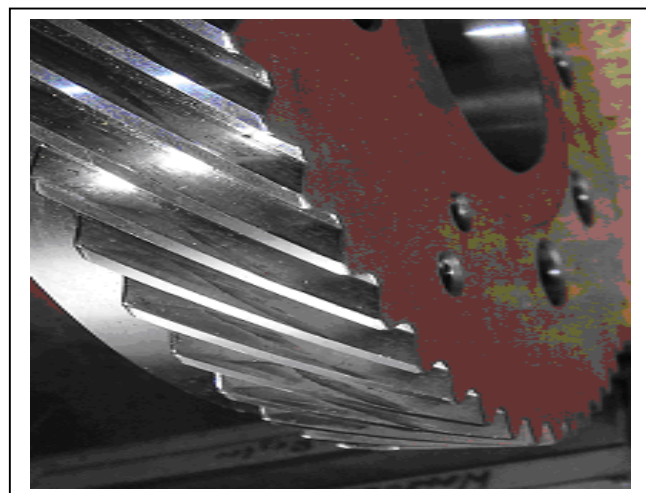
Figure 2
In-line engine M 43
after 7,500 operating hrs.

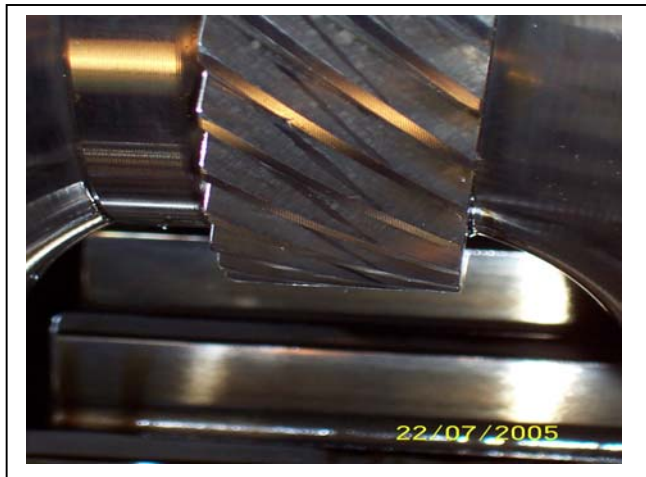
Figure 3
In-line engine M 43
after 21,000 operating hrs.

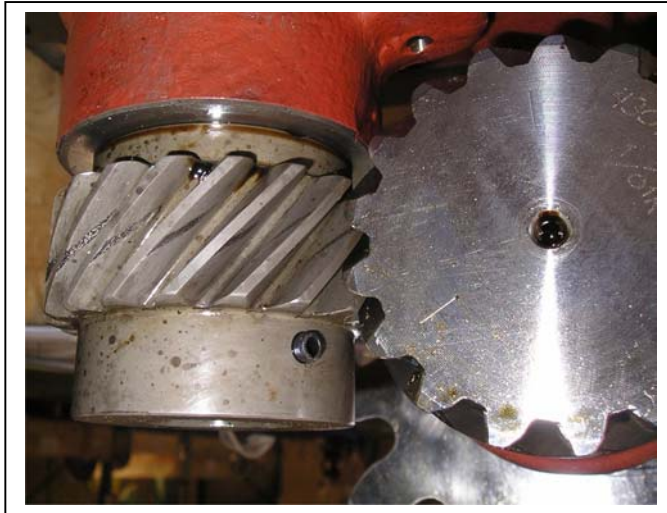
Figure 4
V-engine M 43
after 1,500 operating hrs.

Photos 4 to 5 show normal, perfect running patterns of governor drives at different running hours. The adaptation can be clearly recognized. Slightly palpable running patterns on the gear flanks are totally harmless and permissible. No replacement is required.

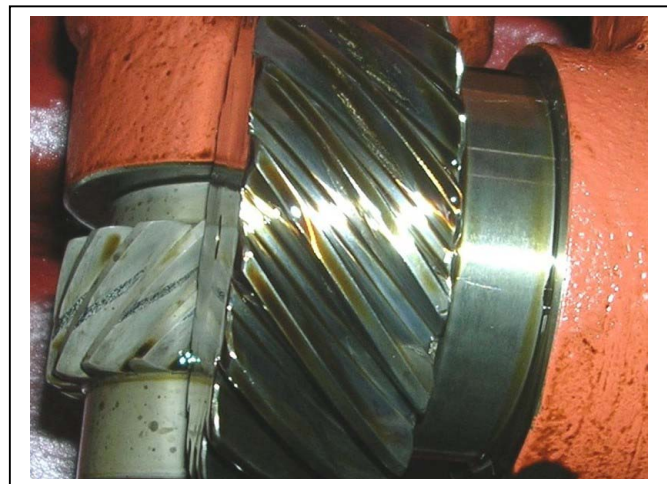
Figure 5
V-engine M 43
after 5,500 operating hrs.
