Service Information No. 02 / 06

Date: 28.06.2006

TPL 73 and TPL 77 turbocharger mounting foot screws

M 43

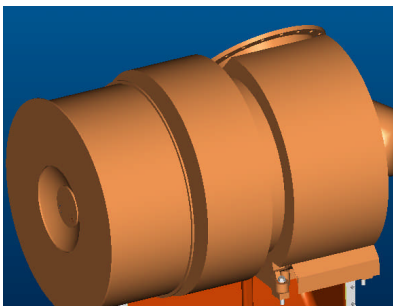
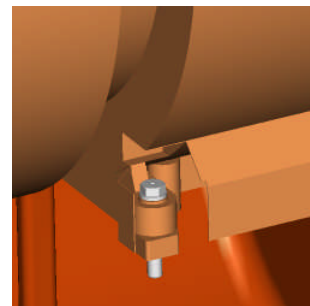
In the past we received sporadic reports of TPL 73 and TPL 77 turbochargers being affected by fracture of a mounting foot screw for fastening on the foundation. The broken screw was always the one opposite the governor.

Investigations into the root cause of the damage have shown that the notching effect attributable to corrosion attacks above the thread had led to vibration fatigue fracture. The corrosion may have been the consequence of condensate forming in the hole of the turbocharger mounting foot caused by the above mentioned admission of relatively cold ambient air.

We, therefore, recommend a regular weekly check of this screw by the crew on board. If the screw should be found to be broken, the voyage can be continued until reaching the next port, where a new screw has to be fitted. Please inform your responsible dealer who has the special tools to carry out this repair.

As a preventive measure we recommend to replace this screw.

Prior to fitting a replacement screw its shank should be properly coated with anticorrosive paint and it should be screwed in while the paint is still wet. You can order the screw from your dealer under catalogue numbers: 437250-18 or 437250-68.

The tightening value for the screws is 750 Nm plus 30° torque angle for the M30 screw (**for TPL 77**) and 640 Nm for the M24 screw (**for TPL 73**). In both cases thread and contact face are to be coated with Molykote. If you do not have an appropriate torque wrench available on board we recommend to call upon your responsible dealer to carry out this job as well.
