## Service Information No. 13/06

### Bedplates, Cracks in the Bearing Blocks

### 8 M 601 C

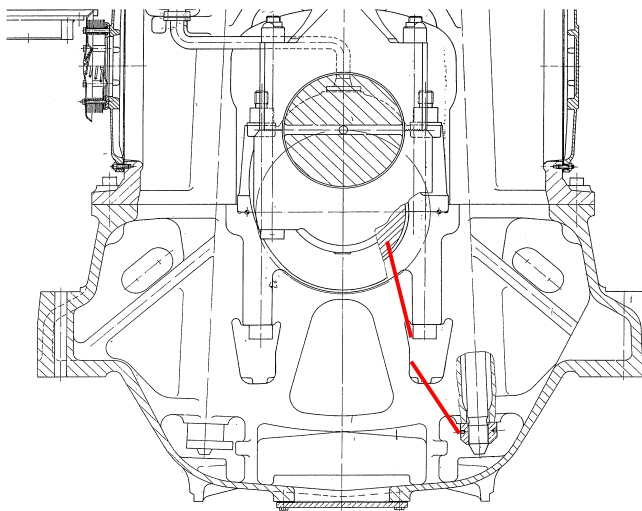
Since 2005, the bedplates of 3 resiliently mounted marine engines have cracked in the bearing blocks. The crack path is nearly identical in all three cases. It is always located at camshaft side according to the attached sketch, i.e. from main bearing bore towards the pocket in which the nut of the bearing cap bolt rests.

At the time the damage happened the affected engines had logged operating times in the range from 46,000 to 70,000 hours.

It has not yet been possible to identify the root cause of these damages. The following operational influences will increase local stress in the affected areas:

- Increased thermal stress due to many start/stop manoeuvres
- Insufficient preheating of the engine before starting
- Influences attributable to the ship's foundation, e.g. due to the ship touching ground
- Pitting corrosion in the main bearing bore due to insufficient bearing pretensioning
- Inclined position and edge pressure of the bearing journal
- Increased dynamic stress due to:
  - Increased firing pressures
  - Unfavourable engine adjustment (significant differences in firing pressure between the individual cylinders)
  - Impact of the fuel
    - Poor ignition quality
    - Insufficient treatment
  - Worn injection components

It is difficult to impossible to identify the actual damage cause over such a long operating period, the more so as there may have been a combination of different causes. We, therefore, recommend to pay attention to the a.m. items and also to carry out regular visual inspections of the bearing blocks.

If a crack is found at an early stage, its propagation could be stopped by stop-drilling and stitching or at least slowed down so that a repair can be scheduled.

According to our estimation based on the information available to us, there will be no acute operational risk for the engine even in case of a crack all through the material. The bearing, however, must not be opened under any circumstances.
