Service Information No. 14/06

Date: 29.12. 2006

Vibration Damper Camshaft Safety Check

7 M 43

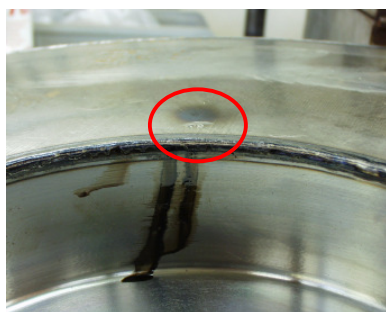
pict. 1

Unfortunately we experienced few damages on these dampers due to overheating which led to a deflagration inside the crankcase. As a result all pressure relief valves in the crankcase doors were actuated as requested without allowing any further gas emission into the engine room.

- Visual inspection of the vibration damper surface for partial discolouration (black caused by oil carbon deposits or yellow to blue caused by overheating. See pict. 1).
- Deformation of the side walls of the dampers housing (see pict. 2).
- Check welding seams for cracks (see pict. 3).
- Check crankcase for residues of viscous fluid as indicator for cracks

Please contact immediately your local dealer if one or more of the above described items are detected.

The defective dampers must be replaced. It is strictly forbidden to carry out any works on the dampers themselves.

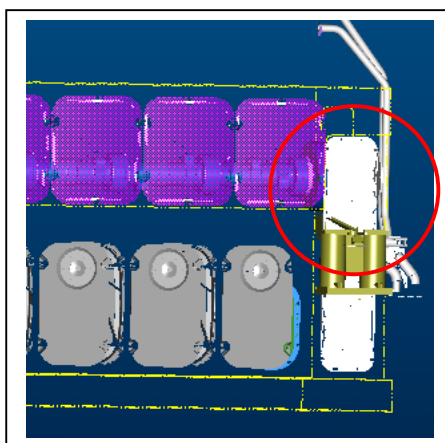
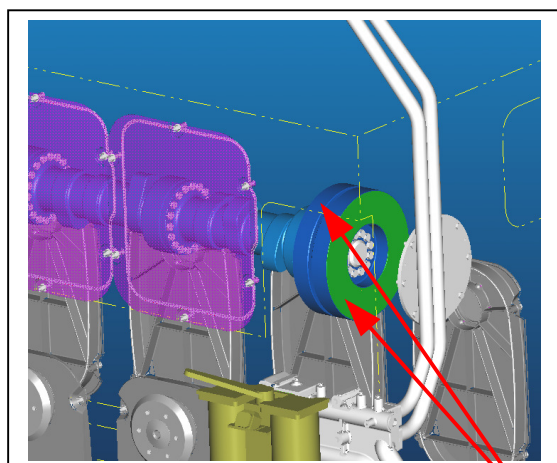
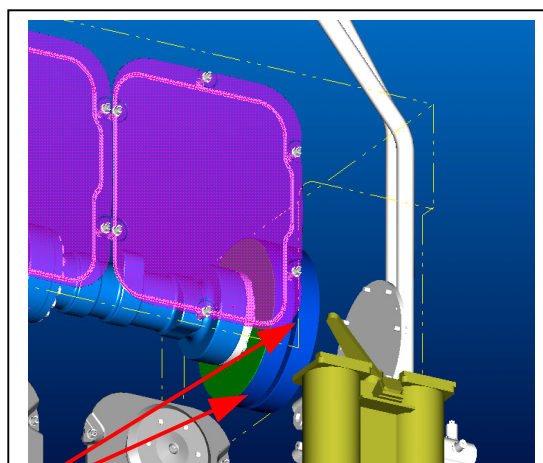
All camshafts of the a.m. engines are equipped with one vibration damper at the opposite flywheel end (see attached sketch).

Welding seam and surface check
Only one damper installed
