Service Information No. 15/06

Date: 29.12. 2006

Vibration Damper Camshaft Safety Check

9 M 43

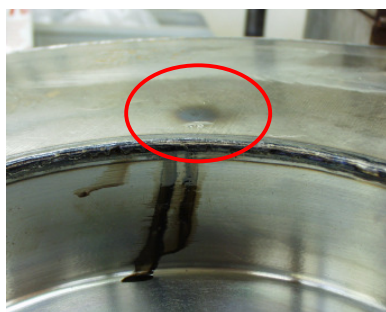
pict. 1

- Visual inspection of the vibration damper surface for partial discolouration (black caused by oil carbon deposits or yellow to blue caused by overheating. See pict. 1).
- Deformation of the side walls of the dampers housing (see pict. 2).
- Check welding seams for cracks (see pict. 3).
- Check crankcase for residues of viscous fluid as indicator for cracks.

Please contact immediately your local dealer if one or more of the above described items are detected.

The defective dampers must be replaced. It is strictly forbidden to carry out any works on the dampers themselves.

Remark: Even if only one damper is found defective both dampers must be replaced.
