Service Information No. 16/06

Date: 29.12. 2006

Vibration Damper Camshaft Safety Check

12 M 43

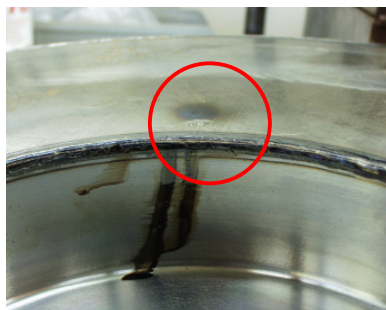
pict. 1

Unfortunately we experienced few damages on these dampers due to overheating which led to a deflagration inside the crankcase. As a result all pressure relief valves in the crankcase doors were actuated as requested without allowing any further gas emission into the engine room.

- Visual inspection of the vibration damper surface for partial discolouration (black caused by oil carbon deposits or yellow to blue caused by overheating. See pict. 1).
- Deformation of the side walls of the dampers housing (see pict. 2).
- Check welding seams for cracks (see pict. 3).
- Check crankcase for residues of viscous fluid as indicator for cracks.

Please contact immediately your local dealer if one or more of the above described items are detected.

The defective dampers must be replaced. It is strictly forbidden to carry out any works on the dampers themselves.
