Service Information No. 01 / 07

Turbocharger TPL 76C; Filter Silencer

8/9 M 43C

TPL76-C, Filter silencer

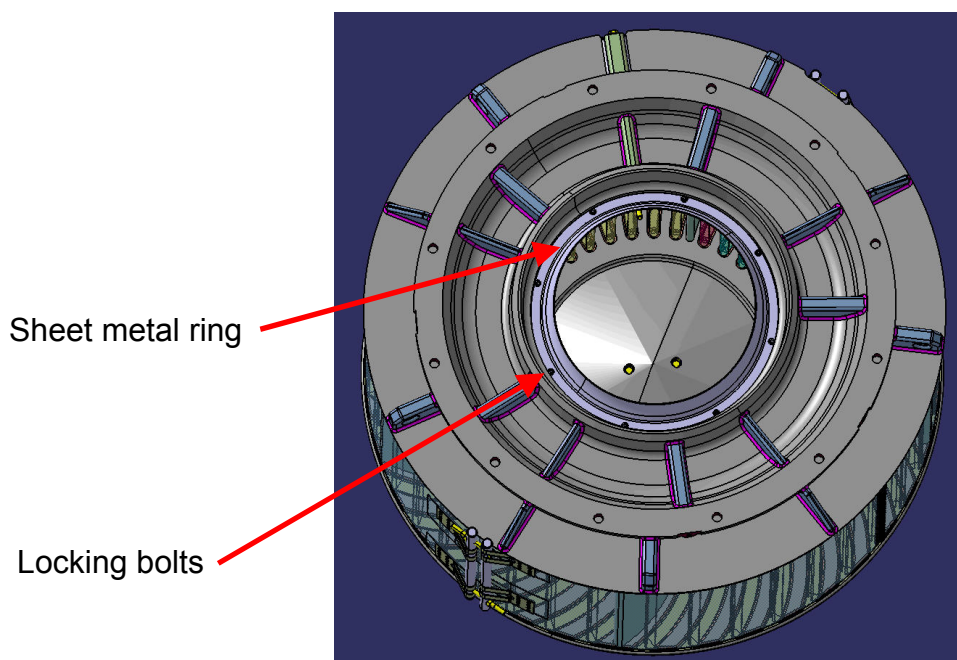
Please note that we have been informed of a defect in the present design of the filter silencer (p/n 81000). The bonding of the sheet metal ring inside the filter silencer has been known to fail, causing damage to the turbocharger.

Investigations carried out in-house have shown that the design and quality of the bonding now being used for the filter silencers does not meet all the requirements necessary for reliable operation of the turbocharger. It has therefore been decided to lock the sheet metal ring in position by means of 8 bolts in addition to the bonding. These bolts are of a special design with an integrated verbus-ripp disc. Loctite will also be used to prevent loosening of the bolts.

Under the terms of the product warranty, silencers supplied for TPL76-C units will be modified as a proactive measure. This procedure will be coordinated by the ABB Service Network. You will be contacted by your local ABB service station for the further scheduling of the modification.
