Date: 14.12.09

RM 43, RM 43 C, VM 43, VM 43 C:

Expansion joint guide tube

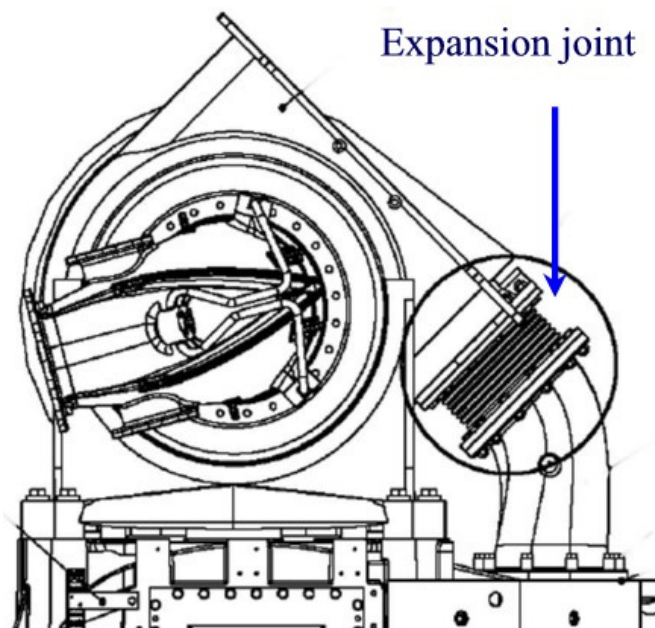
Figure 1

In order to prevent potential damage to the charge air cooler, we recommend that your operating personnel remove the inner guide tube of the expansion joints between exhaust turbocharger and charge air cooler (see figure1). Expansion joints without internal guide tubes have become series standard on our M43C engines. Spare part expansion joints for M43 engines do not have internal guide tubes either.

In order to remove the guide tube, please dismantle the expansion joint during an engine downtime.

Once the guide tube is removed a new gasket is required. This gasket should be made from high-temperature and pressure-resistant material (300°C; graphite with embedded wire) such as Novaform SK from manufacturer Frenzelit or similar gasket material for high temperature.
