Date: February 12, 2018
Subject: Junction box
Engine type: M20C, M25C, M32C, VM32C, M43C, M46DF, VM43C, VM46DF

Engine junction box; unexpected engine shut down

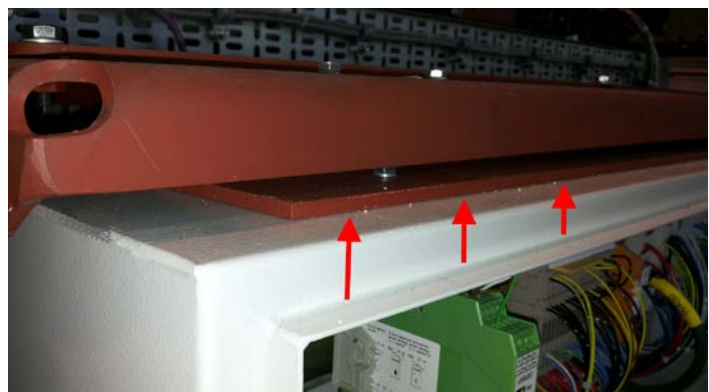
figure 1

Recently we were informed about an unexpected engine shut down due to a short circuit in the engine junction box caused by water while testing firefighting systems.

Deeper investigation revealed that after longer times of continuous water spray on such "transition time junction boxes" water crept under the reinforcement steel plates (figure 1 and 2) and entered the terminals. Such "transition time junction box" can be identified by unused bore holes (figure 3).

In case of installed water sprinkler systems in the engine rooms we recommend increasing the water resistance level of the affected "transition time junction boxes" by applying silicone sealing compound to the upper and lower reinforcement steel plates (figure 4) and to unused bore holes (figure 5). Please follow the application instructions of the sealing compound (degreasing, cleaning....).
