Service Information

Caterpillar Motoren GmbH & Co. KG product support information for medium-speed engines

0032com - Issue 1; January 27, 2025

NOx Sensor Failures

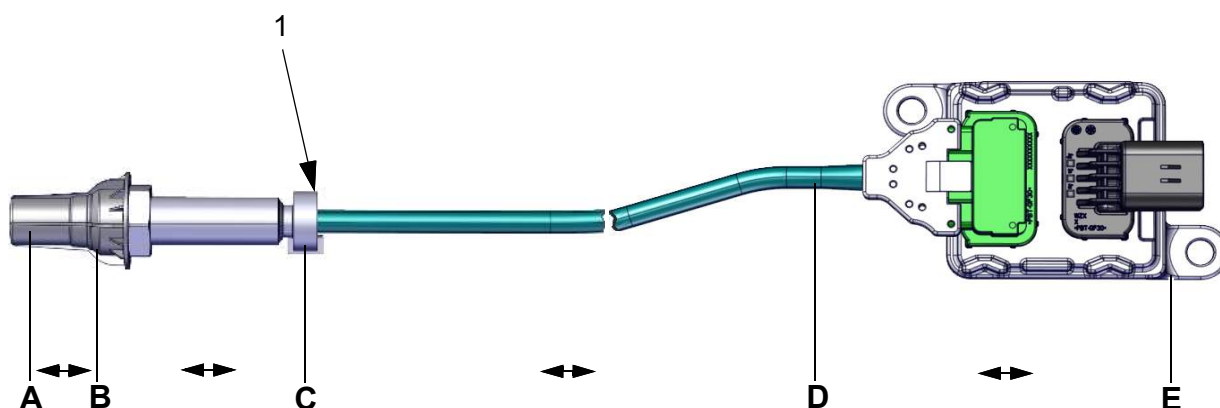
We would like to inform you about potential issues related to NOx sensor failures, particularly those caused by excessive temperatures at the junction (1) between the sensor and the cable. The maximum permissible temperature at this connection point is 200°C. Lower temperatures can increase the performance and significantly extend the service life of the sensor.

Zone	Temp Range (C°)
A - B	-40 to +800
B - C	-40 to +620
C - D	-40 to +200
D - E	-40 to +110

1. Leaks in exhaust insulation:
 - Any leaks can result in higher temperatures reaching the sensor.
2. Aging insulation:
 - Over time, the insulation may degrade, leading to inadequate heat protection of the exhaust pipe and, consequently, higher temperatures at the sensor.
3. Excessive temperature at the sensor-cable junction:
 - Temperatures above the specified limit can cause damage to the sensor and its components.
 - If components are covered with insulation, this can lead to a considerable increase in temperature in the affected areas.

1. Seal leaks in exhaust insulation:
 - Ensure that all insulation is intact and free of leaks, as these can significantly affect temperature levels at the sensor.
2. Check for aging insulation:
 - If the insulation has aged or degraded, replace it to restore proper heat protection.
3. Improve ventilation:
 - Tests have shown that providing active ventilation around the sensor-cable junction can significantly reduce the temperature and prevent sensor damage.
 - Do not cover the components with insulation to ensure adequate ventilation.

We recommend ensuring that the insulation around the exhaust system is intact and in good condition. Additionally, providing adequate ventilation to the sensor connection area will help maintain safe temperature levels and extend the lifespan of your NOx sensor. If you have any questions or need assistance in resolving these issues, please do not hesitate to reach out to your authorized **Caterpillar Motoren** dealer.
