### **KBB Turbocharger HPR 5000 KBB Service Information S071**

Subject: Axial Bearing Wear under Heavy Fuel Operation

## **Wear on the HPR5000 thrust bearing during heavy fuel oil operation**

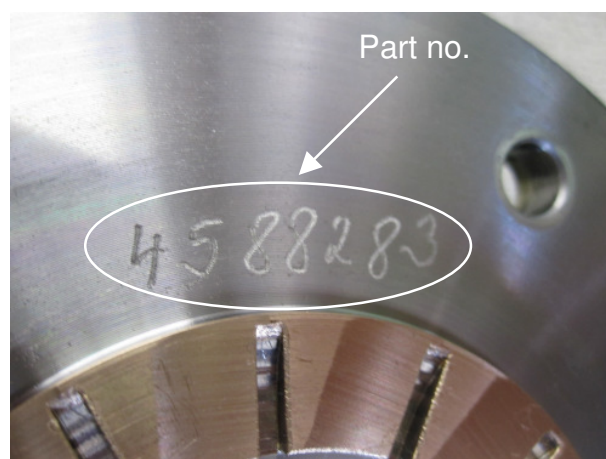
As a consequence of product improvement, Kompressorenbau Bannewitz GmbH implemented design changes to the compressor bearing which result in a longer bearing service life.

Compressor bearings of this new design are identified by the part number **4588283** (Figure 1).

**Figure 1: Compressor bearing, new version – part number**

**Kompressorenbau Bannewitz GmbH recommends that an earlier inspection be performed after 6,000 operating hours for heavy fuel oil operation.**

The compressor bearing has to be replaced if abnormal wear is found during the inspection. Both compressor bearings of the old design (part number **1,69,30062** or **4588290**) and compressor bearings of the new design (part number **4588283**) can be used for this purpose.

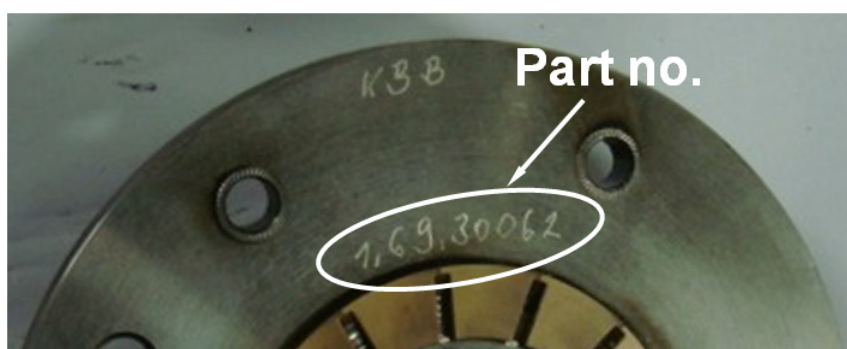
The part number of the bearing is located on the fastening flange of the compressor bearing as shown in Figure 2.

**Figure 2: Compressor bearing, old version - position of part number**
