Date: 06.12.2011
Subject: Condensation water in charge air duct

Engine type: **M25 / M25C**
Page 1 of 4

Condensation water formation in charge air duct

This Service Information is primarily intended for customers whose ships are equipped with MaK M 25 (C) main propulsion plants and frequently sailing in tropical waters.

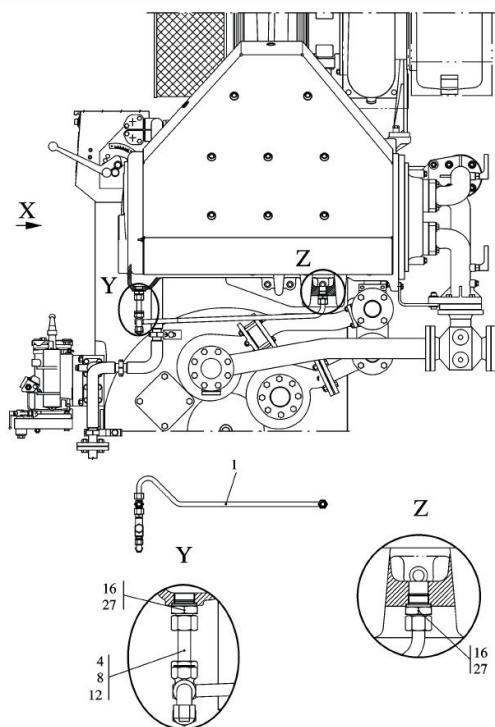
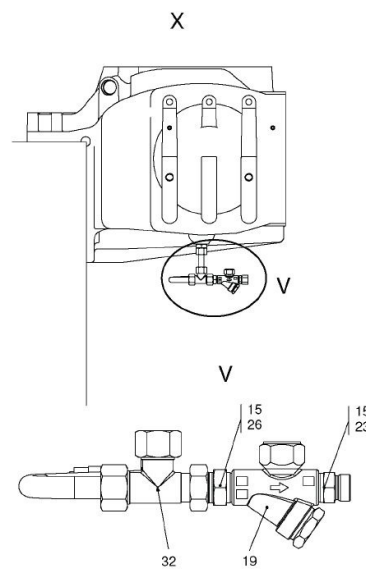
Drain pipe - installation for turbocharging group at the free end

Operating an engine in tropical climate, particularly under high load, may lead to an extreme formation of condensation water in the charge air cooler. This may cause corrosive damage to engine components such as charge air cooler, engine block, and inlet valve stems which, in turn, will affect their operational safety.

In case of an extreme amount of condensation water in the charge air duct which can be recognized by water leaking out of the two permanently open water detection points on the engine we recommend to raise the charge air temperature so that no more condensation water will be visibly leaking out.

- **Engine** = Retrofit of a condensation water drain in the area of the charge air cooler (please refer to pages 2 and 3 for details).
- **LT cooling water system with powered flap valve** = Change over to electronic charge air temperature control. This requires individual adjustments to the pipe system, an adjusting valve (CR1), and an electronic controller such as type 362 MC of Pleiger (please refer to the schema, page 4).
