Service Information No. 0004 M25

Date: September 24, 2015 Subject: Connecting rod

Engine type: M25

Connecting rods to be checked

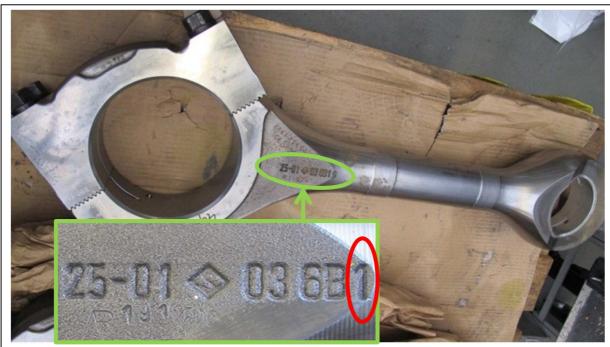
figure 1

Recent field experience has indicated a small risk of the cracking of connecting rods of a particular supplier after long engine operation hours on M25 engines with engine Nos. starting with 42xxx and 44xxx. The connecting rods that are possibly affected were supplied in the time between the beginning of year 2006 and the beginning of year 2007, as original equipment in new engines or as spare parts. These connecting rods have a marking made by the forging die. Connecting rods with markings ending with digit "1" are affected due to potentially undesirable location and orientation (example "25-01 ■ 036B1"; location see figure 1).

Please note that connecting rods with digit "2" at the end of the marking are NOT affected and can remain in operation without restrictions.

Since a failure of the connecting rod can put life and limb of personnel standing next to the engine at risk and pose a threat to the safety of the vessel, we recommend checking all connecting rods installed in M25 engines as well as any spare connecting rod for markings similar to the example above and ending with digit "1" at the next opportunity.

In case affected connecting rods are found, please contact your MaK service dealer for ordering particular rework and magna-flux crack testing immediately. Cracked connecting rods found must be exchanged. A replacement connecting rod will be offered free of charge.

Do not postpone this connecting rod check. Affected connecting rods must be reworked.
