Service Information No. 0004a M25

Subject: Connecting rod

Engine type: M25

Replacement of Service Information No. 0004 M25

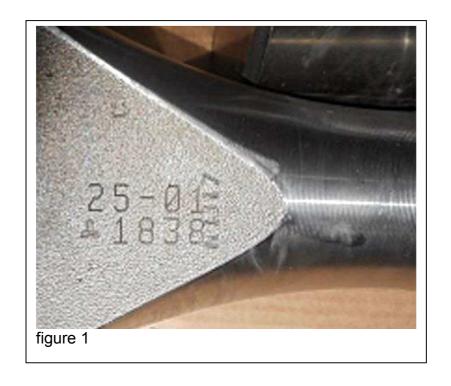
Connecting rods with surface markings similar to figure 1 are NOT affected.

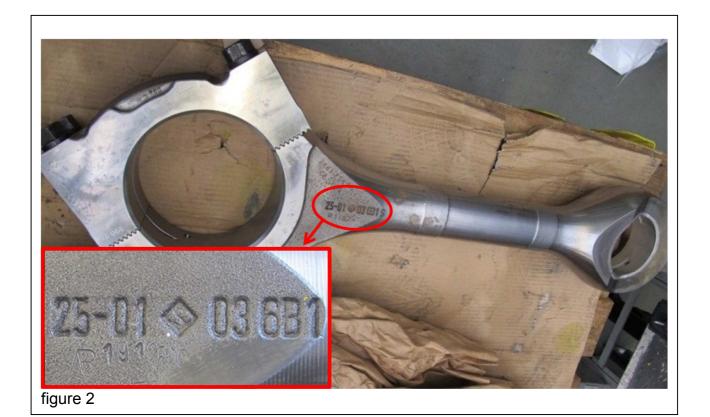
With service information 0004M25, customers operating M25 engines with engine Nos. starting with 42xxx and 44xxx were requested to check all connecting rods on board because they might have connecting rods at risk installed in their engines or delivered as on-board spare. The connecting rods that are possibly affected were supplied in the time between the beginning of year 2006 and the beginning of year 2007, as original equipment in new engines or as spare parts. These connecting rods have a deep marking made by the forging die.

Since a failure of the connecting rod can put life and limb of personnel standing next to the engine at risk and pose a threat to the safety of the vessel, we recommend checking all connecting rods installed in M25 engines as well as any spare connecting rod for deep markings similar to figure 2 at the next opportunity. If present, the affected connecting rods have to be reworked and crack tested. Contrary to the information given earlier, the shape of the last digit, whether it is "1", "2" or a letter, does not matter.

In case affected connecting rods are found, please contact your MaK service dealer for ordering particular rework and magna-flux crack testing immediately. This task will be supported by us in covering a substantial amount of the labour cost involved. Due to the fact that engine warranty period has expired please understand that we cannot cover all cost that will occur in this regard. Cracked connecting rods found must be exchanged and will be offered at no cost to you.

Do not postpone this connecting rod check. Affected connecting rods must be reworked.
