Service Information

Engine platform: M32
Engine section: fuel pipes

No. 0014M32 - Issue 1; Aug. 11, 2023

Fuel Pipes

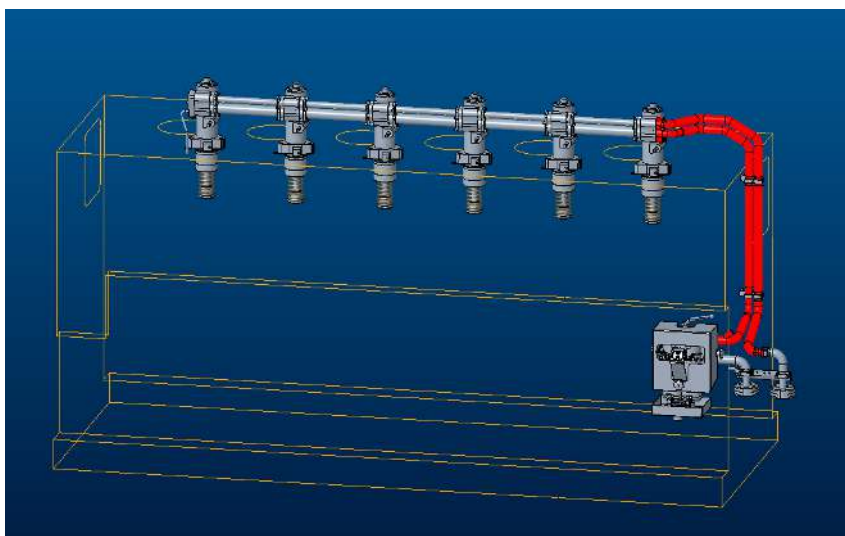
figure 1

In individual instances, the fuel supply and return pipes installed to the first injection pump have developed cracks or experienced fractures during operation on M32 engines (figure 1).

⚠ CAUTION
	<p>Danger due to leaking fuels and oils!</p> <ul style="list-style-type: none"> • In the worst case such cracks or fractures could result in fuel spilling from the pipes and igniting on hot surfaces. • Contact with fuels or engine oil may cause damage to health on the skin, in the eyes and in the respiratory tract.

In order to mitigate the risk of cracks and fractures, we strongly recommend to include checks of the pipes in the daily routines on board. During the checks, particular attention should be paid to the pipe brackets, the flange connections and the weld seams.

If damage is found, the tubes and brackets, including all screws, should be replaced. Any missing brackets should be promptly re-installed.
