Date: 14.10.2014
Subject: Turbocharger type NR24/R

Engine type: **8M 282/ 8M 332 / 8M 332C**
Page 1 of 1 plus attachments

Service Information 0001M332; Update 2014; Containment level of turbocharger type NR24/R does not reflect current safety standards

**Update to the ASB2013/02/18 and its supplement for marine applications
(product safety warning for turbocharger types NR12, NR14, NR15, NR17, NR20, NR24, NR26,
NR29, NR34, NA29 (consolidation of ASB2013/04/22 and supplement), NA34, NA40, NA48, NA57,
NA70)**

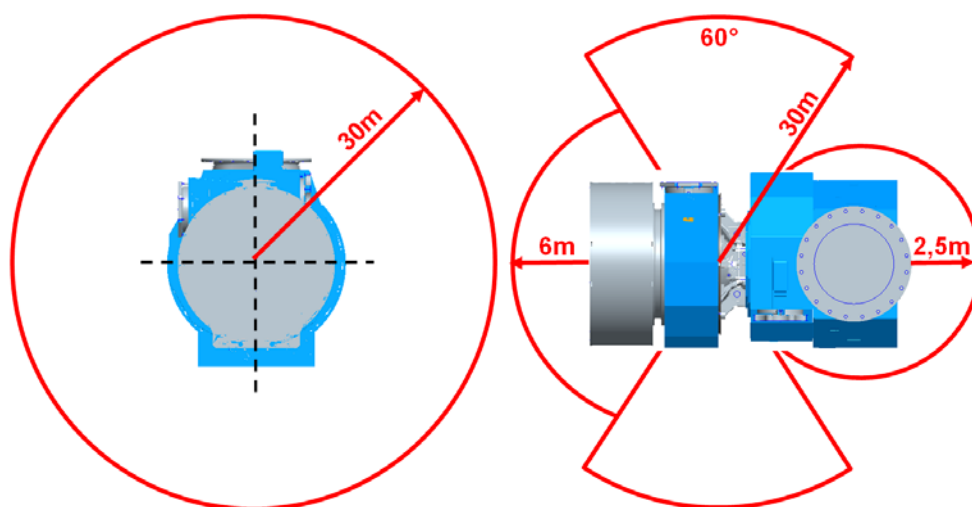
- Do not unnecessarily dwell in the vicinity of a turbocharger while it is in operation. MAN has defined a possible hazardous area (see below) which should be avoided while the turbocharger is in operation, unless required for the safe operation of the vessel/plant.
- Wear appropriate protective clothing as recommended in the Instruction Manual of your turbocharger.

Fig. 1: Red zone = hazardous area (extended compared to the area in the Instruction Manual). We are aware that in most cases the space available around the turbocharger(s) is less than the given 30 m. However it indicates the area where the highest risk is assumed.

Work item	Description in the manual	Recommendation
901 / 501	Inspection for abnormal noise and vibrations	Stay out of the hazardous area (ref. Fig. 1) for this inspection. In case of an abnormal noise stay away from the turbocharger, stop the engine immediately, identify and eliminate the source of the noise before re-starting the engine.
903	Check turbocharger and system pipes for leaks	If possible, carry out this work ideally when the engine is stopped. Oil leaks as well as gas leaks can normally be identified by residues even when the engine is stopped.
905 / 508	Check all the fixing screws, casing screws and pipe connections for tight fit	Carry out this inspection only when the engine is stopped.
911 / 504	Turbine dry cleaning	Use it regularly at reduced engine load of 15% or below. Operating experience has shown that for turbochargers that are equipped with a turbine dry cleaning device only, the dry cleaning of the turbine below 15% engine load (as recommended) may not provide the desired result. In case no wet cleaning device is installed, we recommend to retrofit it for a proper cleaning effect below 15% load.

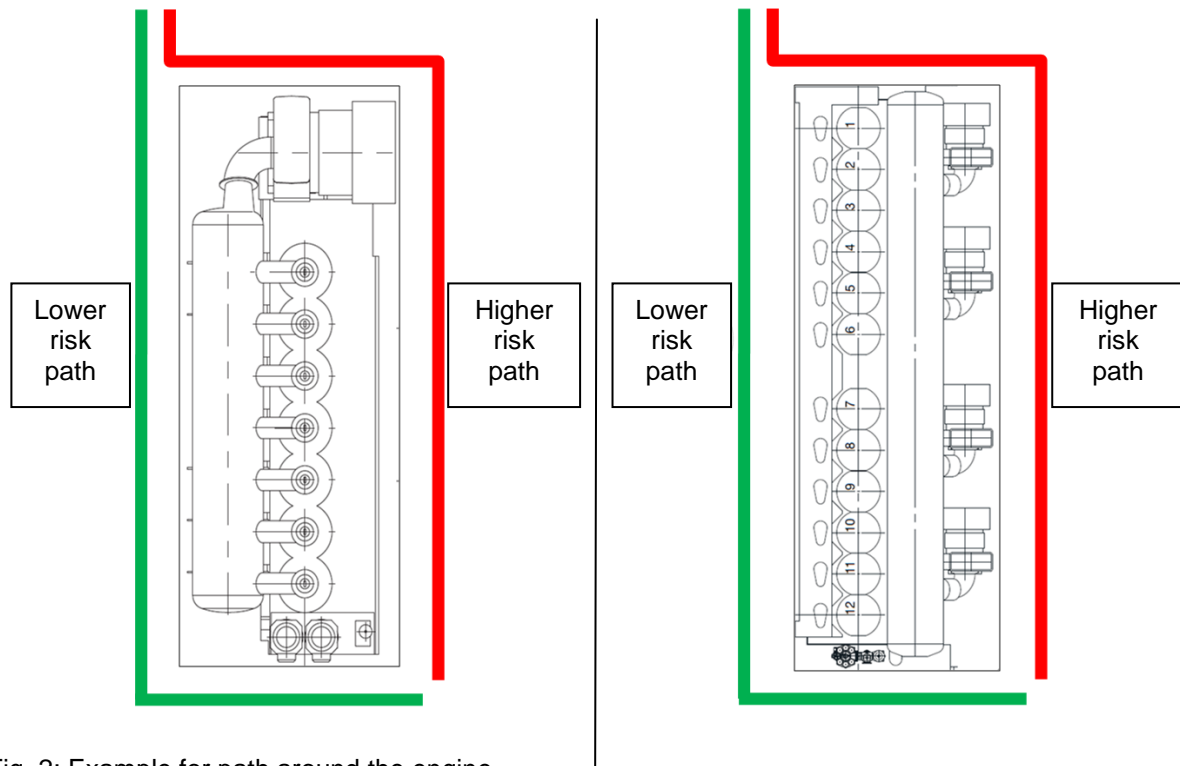
Optimize your path through the engine room in order to minimize your stay in the hazardous area.
(Please note that in the context of the illustration also the green path can only be seen as the lower risk path)

Fig. 2: Example for path around the engine

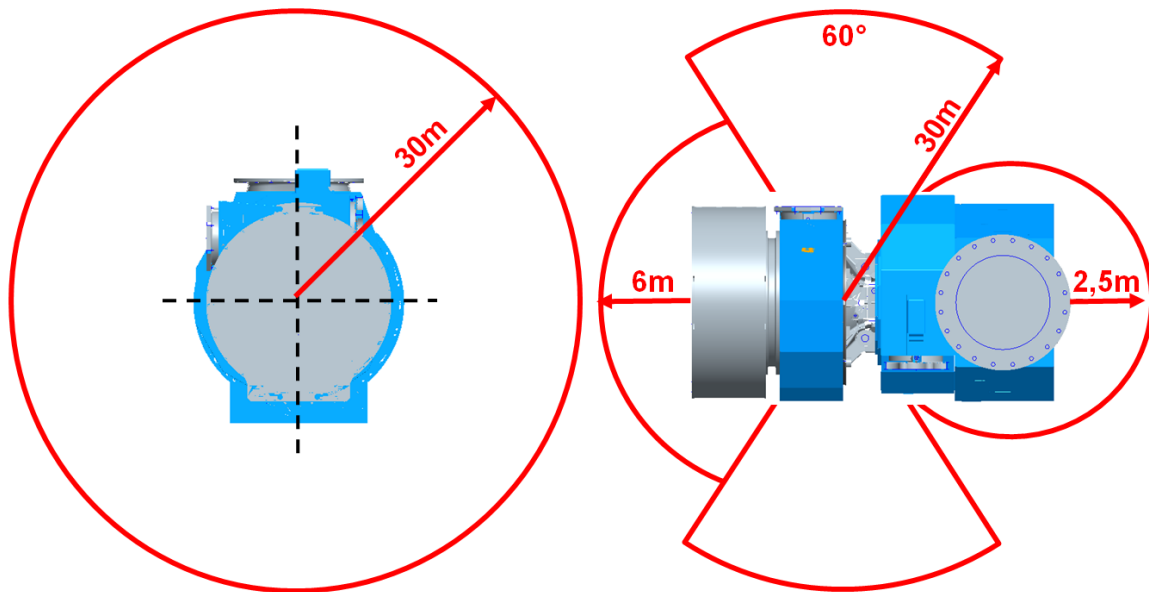
1. We recommend to prohibit all persons to access the hazardous area of the turbocharger, Fig. 1, at least during the first 4 hours of operation (run-in period) of the engine.
2. In our assessment, the risk of a critical compressor wheel damage decreases after the run-in period if the above measures reducing the risk of foreign object damage are observed, so that MAN will, for its own testing and commissioning activities, allow access to the hazardous area to personnel that have been properly and fully instructed about the prevailing dangers.

Fig. 1: Red zone = hazardous area (extended compared to the area in the Instruction Manual)
