Date: 06.12.10
Subject: Fuel Cam Follower

Engine type: **M 43 C**
Page 1 of 2

M 43 C Fuel Cam Follower

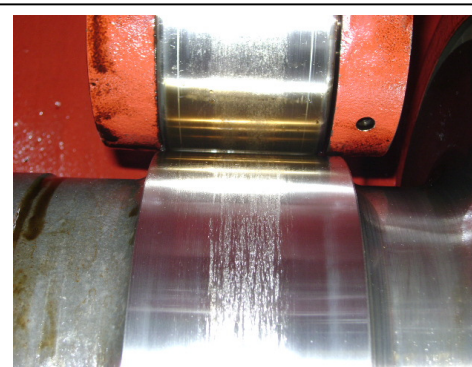
Figure 1

There have been isolated cases of irregularities regarding the operating behaviour of the fuel cam follower roller after long operating periods. In these instances the bearing bush in the roller was observed to have moved. In individual cases this may cause contact marks on the roller and, as a consequence, damage to the fuel cam follower.

1. **Visual inspection** of fuel cam and roller for unusual marks: This does not refer to the circumferential marks described in Service Info 03-05 "Running Patterns of Rollers and Cams". Please check the roller for grinding marks and/or material transfer from the roller to the fuel cam (see Figure 1).

please contact your MaK agency as soon as possible in order to have the findings confirmed and a repair carried out if required. If this cannot be done within a short timeframe, the engine can continue to operate. In this case the affected assembly should be inspected in each port and the trend should be documented. Latest, however, if material crumbling occurs on roller, bush or cam, the assembly needs to be promptly replaced.

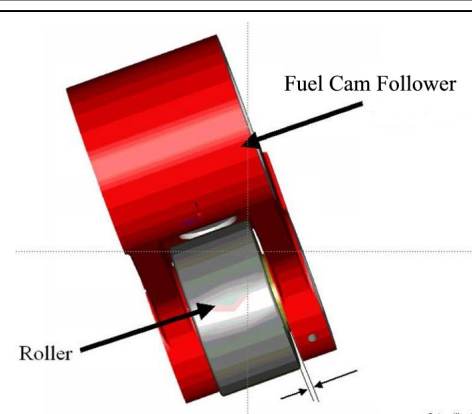
Figure 2

3. **Visual inspection** to determine if the bronze-coloured bush of the roller is visible (see Figure 2). If the roller is in proper condition, the bush should not be visible.
