Service Information

Engine platform: M43/M46DF
Engine section: Engine block

No. 0021M43 • Issue 1; February 13, 2023

M43C/M46DF Inline - Engine block cam shaft bearing support

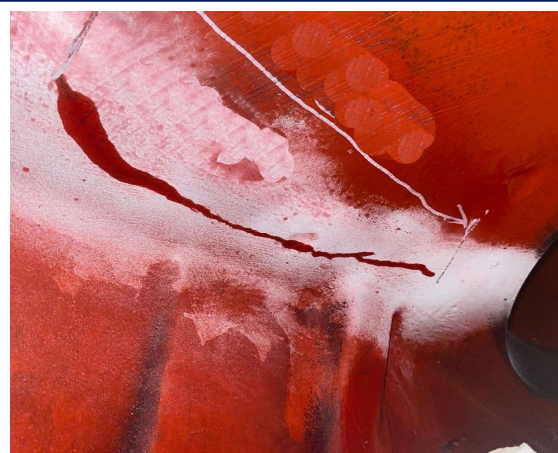
figure 1

Continuous monitoring of our engine type product health indicated a rare occurrence of cracks in the engine block below the camshaft bearing.

It was found that the presence of small irregularities in the cast skin, combined with high engine loads and frequent load changes, could possibly initiate crack propagation.

Figure 1 shows a severe crack as seen from the side of the crankcase. Figure 2 shows the same crack seen from the side of the camshaft compartment, directly below the camshaft bearing. Depending on the classification society, such a crack can be repaired by metal stitching. Longer cracks are beyond repair and a new engine block is indicated.

As a precautionary measure, we recommend checking the camshaft bearing by means of Magnaflux for small cracks in the casting skin or casting flaws. All irregularities must be ground out and compressive stresses applied to the surface. After these measures, the engine block can be considered reliable for the life of the engine.
