Service Information

Engine platform: M 43
Engine assembly: Cylinder head

No. 0022M43 – Issue 1; 25 July 2023

Tightening torque check of ignition fuel injectors

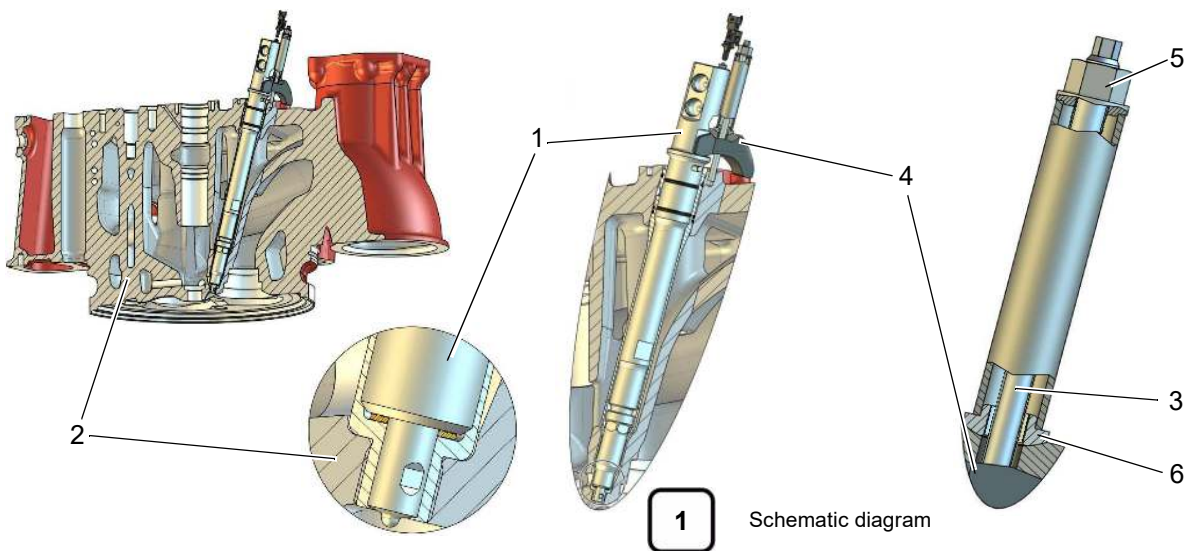
We have received information from the field that there have been isolated cases of leaks ("*blow-bys*") in the sealing area between the ignition fuel injector (1) and the cylinder head (2).

The cause investigation revealed that the required tightening torque of the collar nut (5) was, in isolated cases, lower than the specified **55 Nm**.

To avoid possible functional impairments, we recommend checking the tightening torque of the collar nut (5) on all the clamping holders (4) of the ignition fuel injectors (1) and retightening them to **55 Nm**, if necessary.

Each time an ignition fuel injector is reinstalled or replaced, the tightening torque of the collar nut must be checked again after another **200 engine operating hours**.

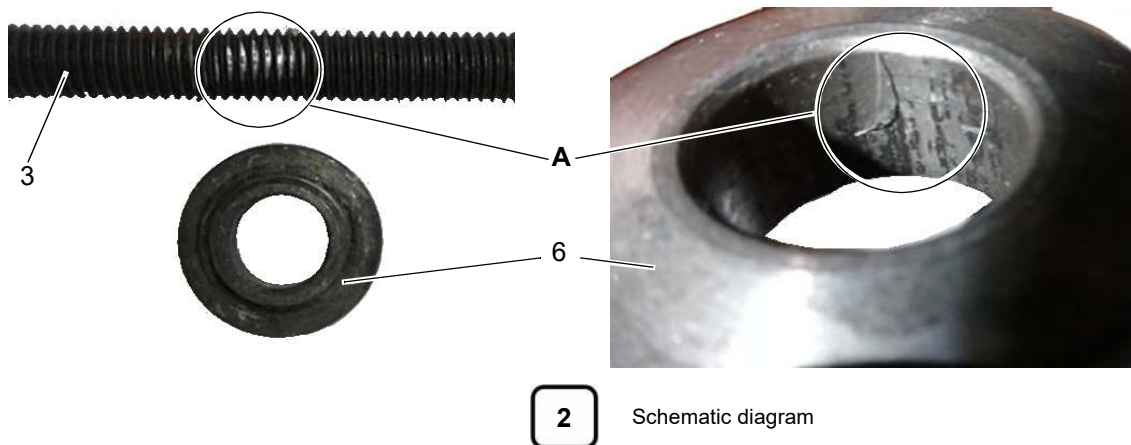
Furthermore, when installing the clamping holder (4), it is imperative to ensure that the stud (3) and the centering piece (6) are aligned to each other when tightening the collar nut (5). If the stud is bent (*deformed*) or the centering piece leans over due to improper tightening, the stud bolt will come into contact with the centering piece in the lower area (**Fig. 2/A**). This can subsequently lead to a fracture in this area.

If contact marks are found on the stud, as shown in **Fig. 2/A**, the stud (3) must be replaced (see last page)!
