Service Information

Engine platform: M32 Engine section: Crankshaft Engine type: 9M32 / 9M32C Validity: until further notice

No. 0009M32 • Issue 1; April 16, 2019

Crankshaft issues on 9M32 / 9M32C

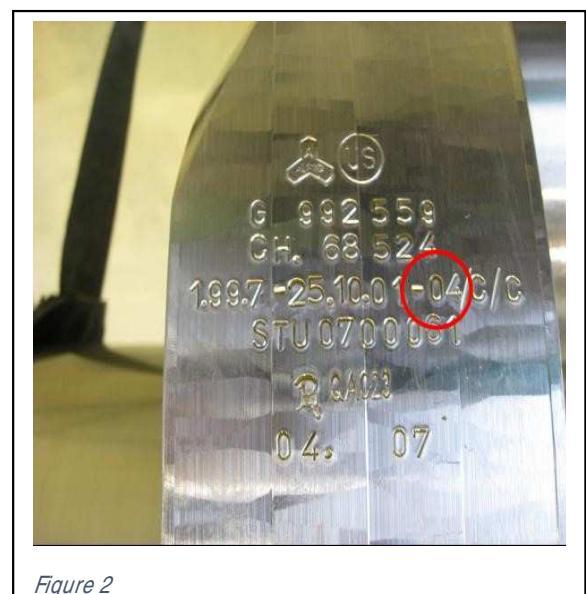
Figure 1

As only certain variants of 9M32 crankshaft are potentially affected, we recommend checking your 9M32 / 9M32C engine for the installed crankshaft variant first. The respective marking can be found on a crank web (see figure 1+2; the variants are marked with a red circle). In case a crankshaft of variant -02, -03 or -04 is installed, please contact your local MaK Service Representative and ask for an offer for a crankshaft check to avoid potentially significant unplanned engine downtime caused by a damaged crankshaft.
