Service Information No. 03 / 05

Running Patterns of Rollers and Cams

VM / RM 43

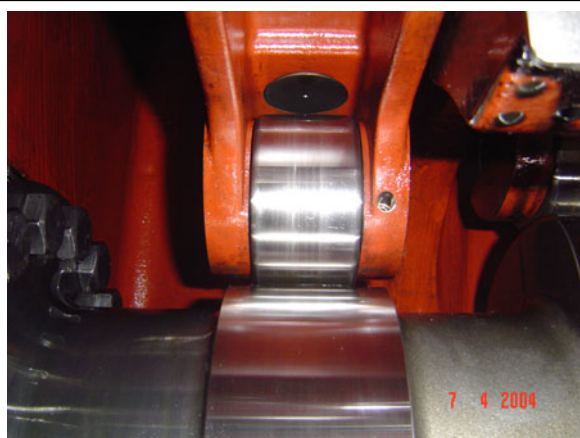
Inlet roller and cam after 70 operating hrs.

Already after a very short operating time, in some cases already after testbed trials and latest during commissioning, clear running patterns can be recognized on the cams and rollers of inlet and exhaust valves, which still become more pronounced during the first 1,000 operating hours. During further operation this process comes to a standstill and the running patterns will change only insignificantly depending on the operating conditions. These running patterns are normally hardly palpable and do not affect operational reliability. Repeated cam inspections on many engines with different operating hours have confirmed this.

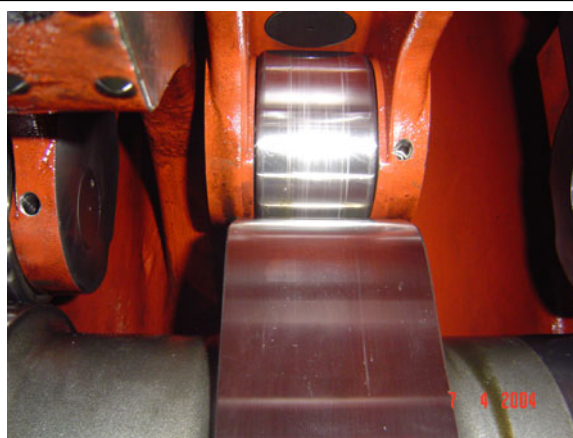
Exhaust roller and cam after 70 operating hrs.

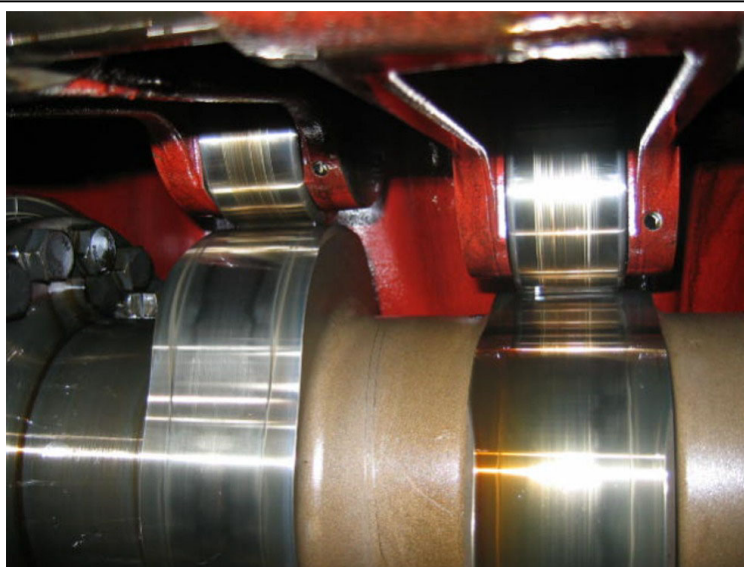
Inlet and exhaust rollers and cams after 4,000 operating hrs.
