Service Information No. 16 / 05

Date: 18.11.2005

Experience with Ring Groove Wear - Update

M 43

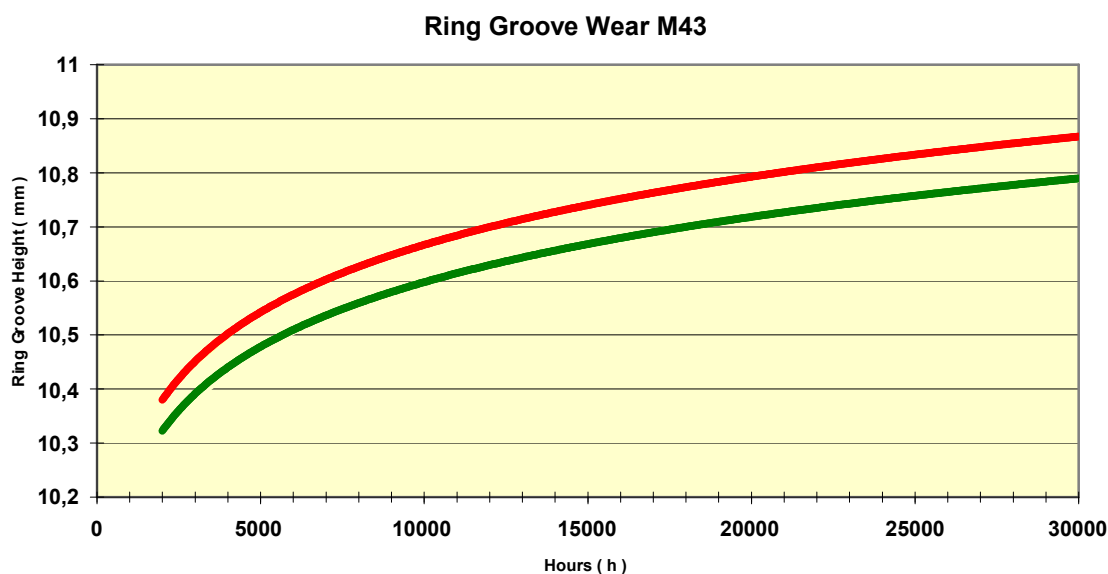
In the attached diagram considerably more than 90 % of the mean values measured at 4 points in the ring groove are below the lower green line. (measured 2mm from the outside, as shown on the standardized Measuring Sheet "Piston")

As long as the values obtained through different checks remain within this range, a wear value of 10.8 mm will only be reached after more than 30,000 operating hours.

If wear values are between the first and the second line, it is to be assumed that a value of 10.9 mm will most probably not be exceeded before 30,000 operating hours.

However, in such a case the operating conditions should be critically analyzed. It cannot be excluded that operational reasons are playing a role in this slightly increased wear. This particularly includes the area of combustion, notably fuel quality, viscosity at the engine, and the condition of the nozzles.

If the wear values are above the red line, we urgently recommend to investigate into the cause and possibly pull another piston to validate the result.

As long as the measured wear values are below the green line, it can be assumed that earliest at 30,000 operating hours a normal piston maintenance will be necessary.

Piston crowns only have to be exchanged when a wear with an average value of 10.8 mm in the first ring groove is reached, unless other reasons call for an earlier exchange.
