Service Information No. 10 / 07

Bracket on emergency air pipe for stop cylinder

VM32C

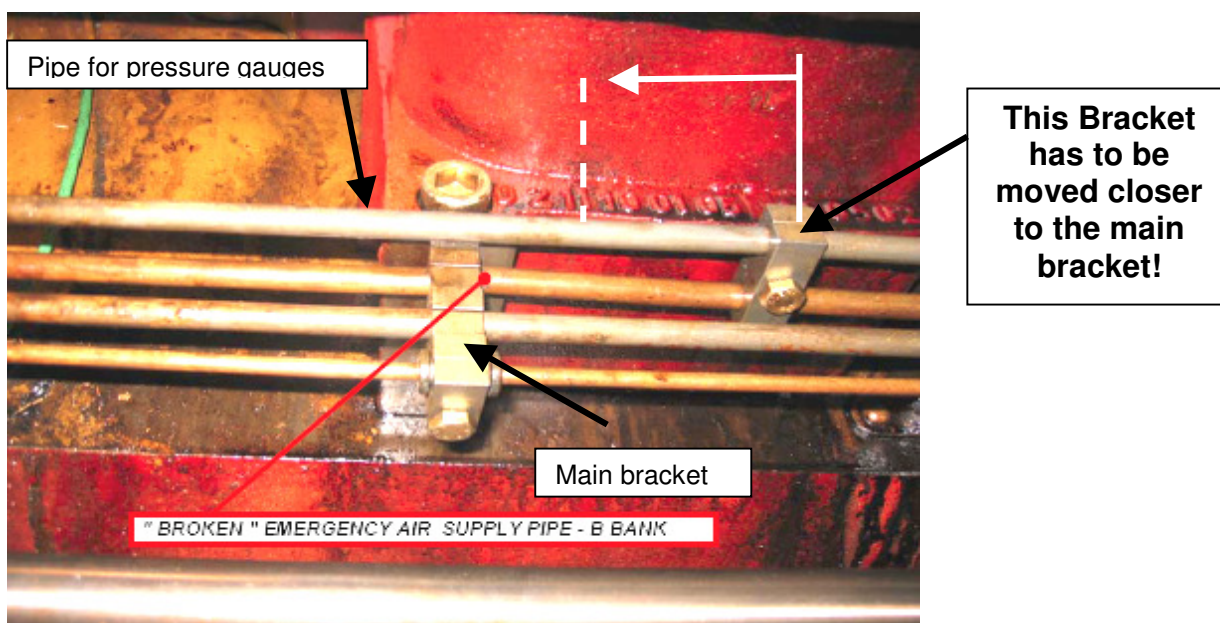
In some few cases the air supply pipe for the emergency stop cylinders broke close respectively directly on the main bracket as indicated on the photo.

Due to the position of the pressure gauge pipe bracket, as shown on the photo, vibrations were transmitted to the air supply pipe for the emergency stop cylinders, which caused the pipe failure. Therefore the position of the bracket has to be checked and if necessary corrected.

It is necessary to check the position of the double clamping's at the emergency air pipe for the stop cylinder.

As shown on the following photo the clamping has to be moved close to the main bracket.
