Service Information

Engine platform: M43
Engine section: Connecting rod

No. 0024M43 - Issue 1; October 11, 2024

Connecting Rod Small End

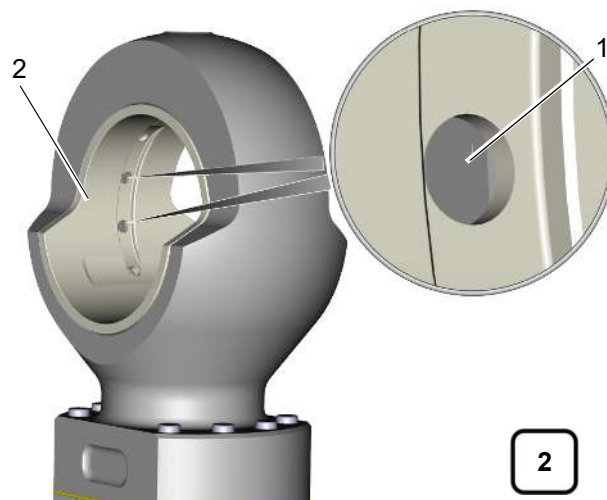
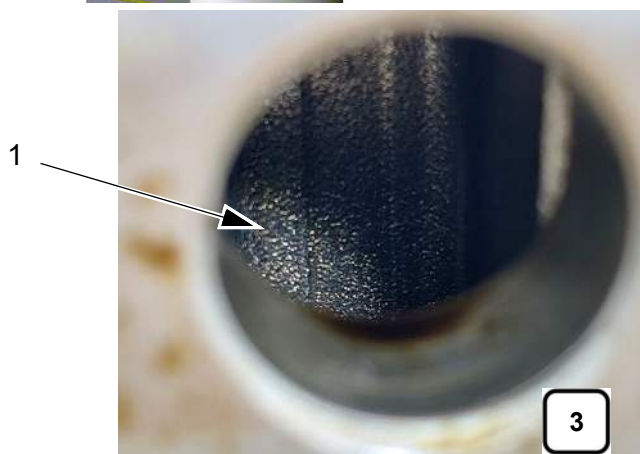
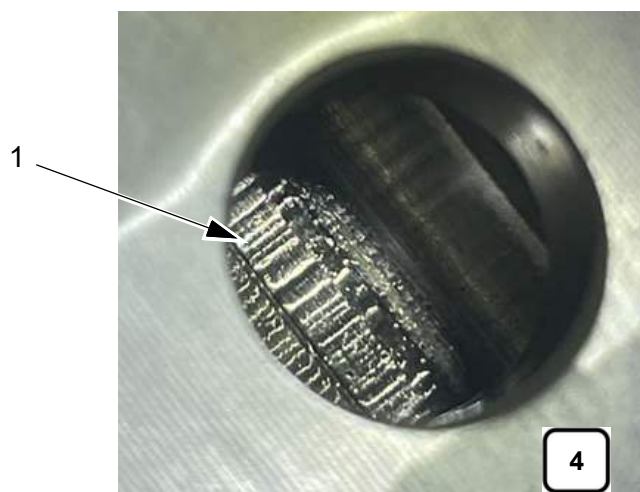
Oil groove inspection of small end

1. Follow the steps listed in the job card **A5.05.02.08.01.10**
2. Perform a visual inspection of the oil groove (2/1) behind the small end bush (2/2).
3. If the surface of the oil groove has been clearly compressed/shot-peened (3/1), the tested connecting rod small end can be used for further engine operation.
4. If machining marks (4/1) are clearly visible in the oil groove of the small end, contact your authorized Caterpillar Dealer immediately to check whether the connecting rod needs to be replaced.
5. Take photos to document each oil groove, mark them with production lot and sequence number and share the photos with your authorized **Caterpillar** Dealer regardless of the results..
