Service Information No. 05c /08

Connecting Rod Safety Checks

M32 C engine No. 38479, 38480, 38481, 38599, 38600

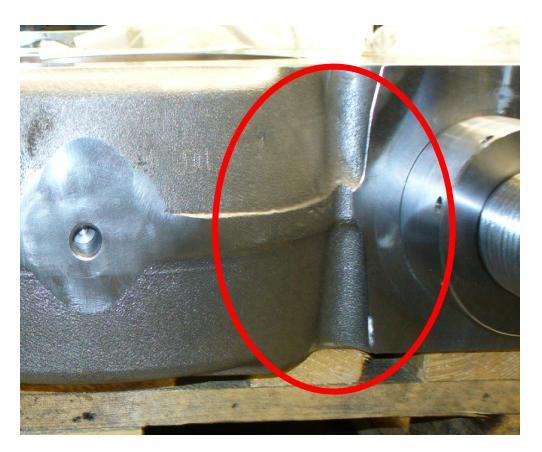
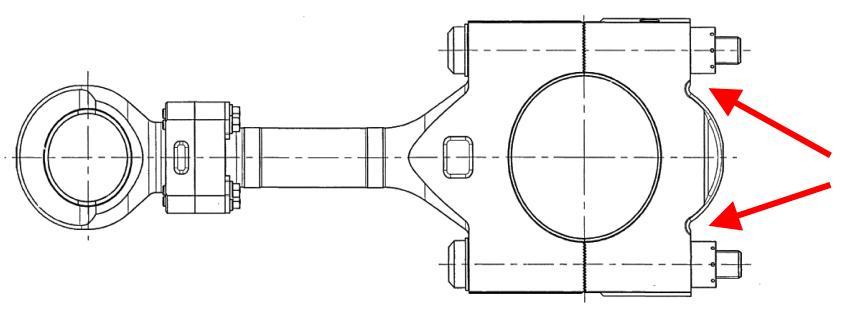
The photograph below shows an uncritical connecting rod.

According to our knowledge, the above mentioned engines are very close to their commissioning dates. In order to minimize the risk of a failure on these engines, it is required that you immediately perform a visual check of the areas concerned on all cylinder units and send detailed digital photographs to your CAT dealer. Please refer to the photographs above for the area to be photographed.

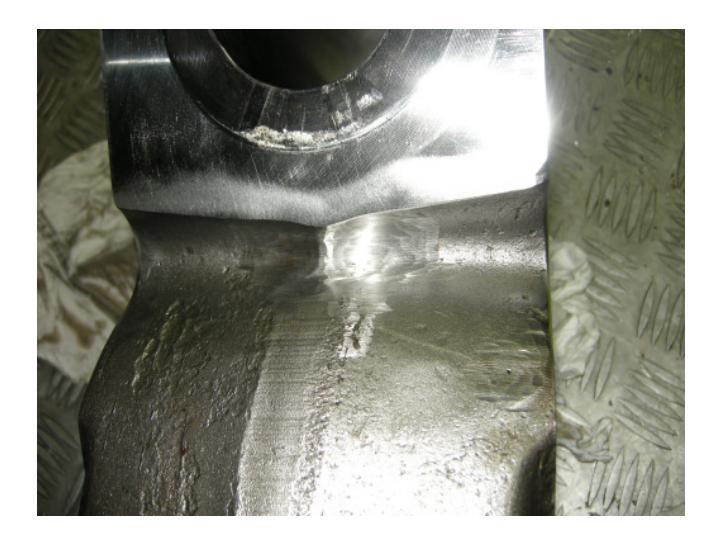
Due to recent findings, we have to inform you about a possible risk we have found on the bottom part (bearing cap) of the connecting rods installed in the a.m. engines. According to these findings, there is a risk that a combination of a number of negative influences may result in the development of a crack during engine operation. Potential influences are the following:

- A relatively sharp peak is formed in the centre of the groove
- A grinded surface is uneven
- Grinding traces are in longitudinal direction of the groove

The photograph below shows a connecting rod at risk.

Your dealer will respond as soon as possible to tell you whether the parts built into your engine are at risk and, if necessary, inform you about the next steps to be taken. The engine must not be started until your CAT dealer has given you this response.

Based on the inspection performed by yourself, a team of specialists will come onboard in order to perform more in-depth checks and possibly rework suspicious surfaces. Your servicing dealer will contact you in order to align possible dates for these visits.
