Joint ring at injection valve

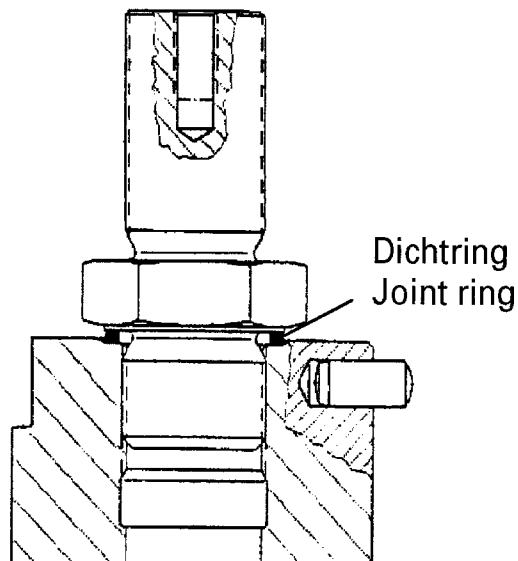
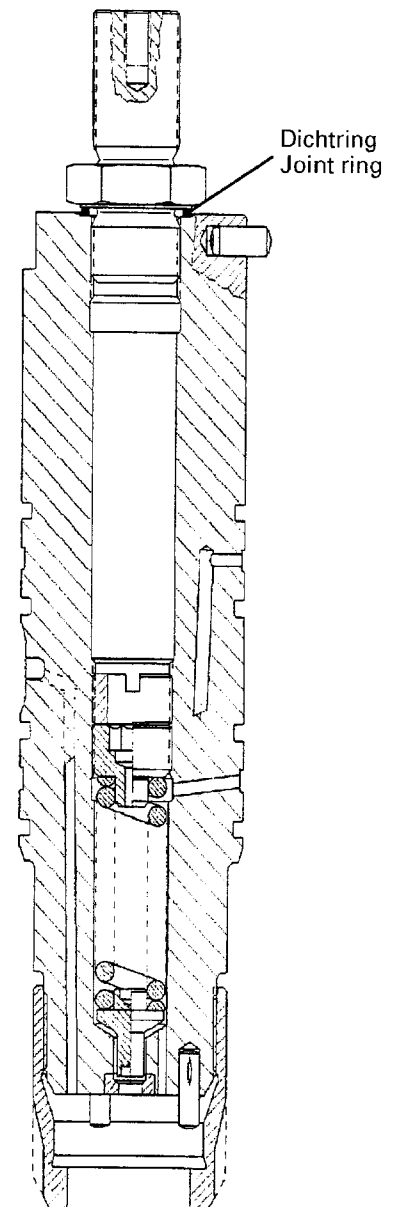
The injection valve on the M 25 engine has proven optimum reliability in both operation modes, MDO and HFO. This injection valve, however, must be carefully completed. During assembly of the upper locking screw deformations to the joint ring might occur. This could lead to leak fuel with following contamination of the lubricating oil.

When completing an M 25 injection valve, attention must be paid to the following:

- The joint ring must be centered.
- The locking screw is to be tightened with a torque of $M = 90 - 120 \text{ Nm}$.
- The joint ring must be checked visually once more for correct fitting. Otherwise, the before-mentioned procedure is to be repeated with a new joint ring.
